**LEAVENWORTH CITY COUNCIL  
Study Session Agenda  
City Hall – Council Chambers & Zoom  
August 11, 2026 | 5:30 – 6:50 PM**

This time is provided for the Council to review the 2022 Residential Alley Study Technical Memo and have an open discussion about alleys within the City.

The purpose of this technical memorandum is to document existing alleys within the city limits of Leavenworth, Washington. This analysis will include recording the existing conditions of the alleys, defining problem areas, and providing recommendations for improvements and maintenance costs based on the City of Leavenworth's (City) standard alley design, as described in this technical memorandum. The City retained RH2 Engineering, Inc., (RH2) to perform and analyze this work.

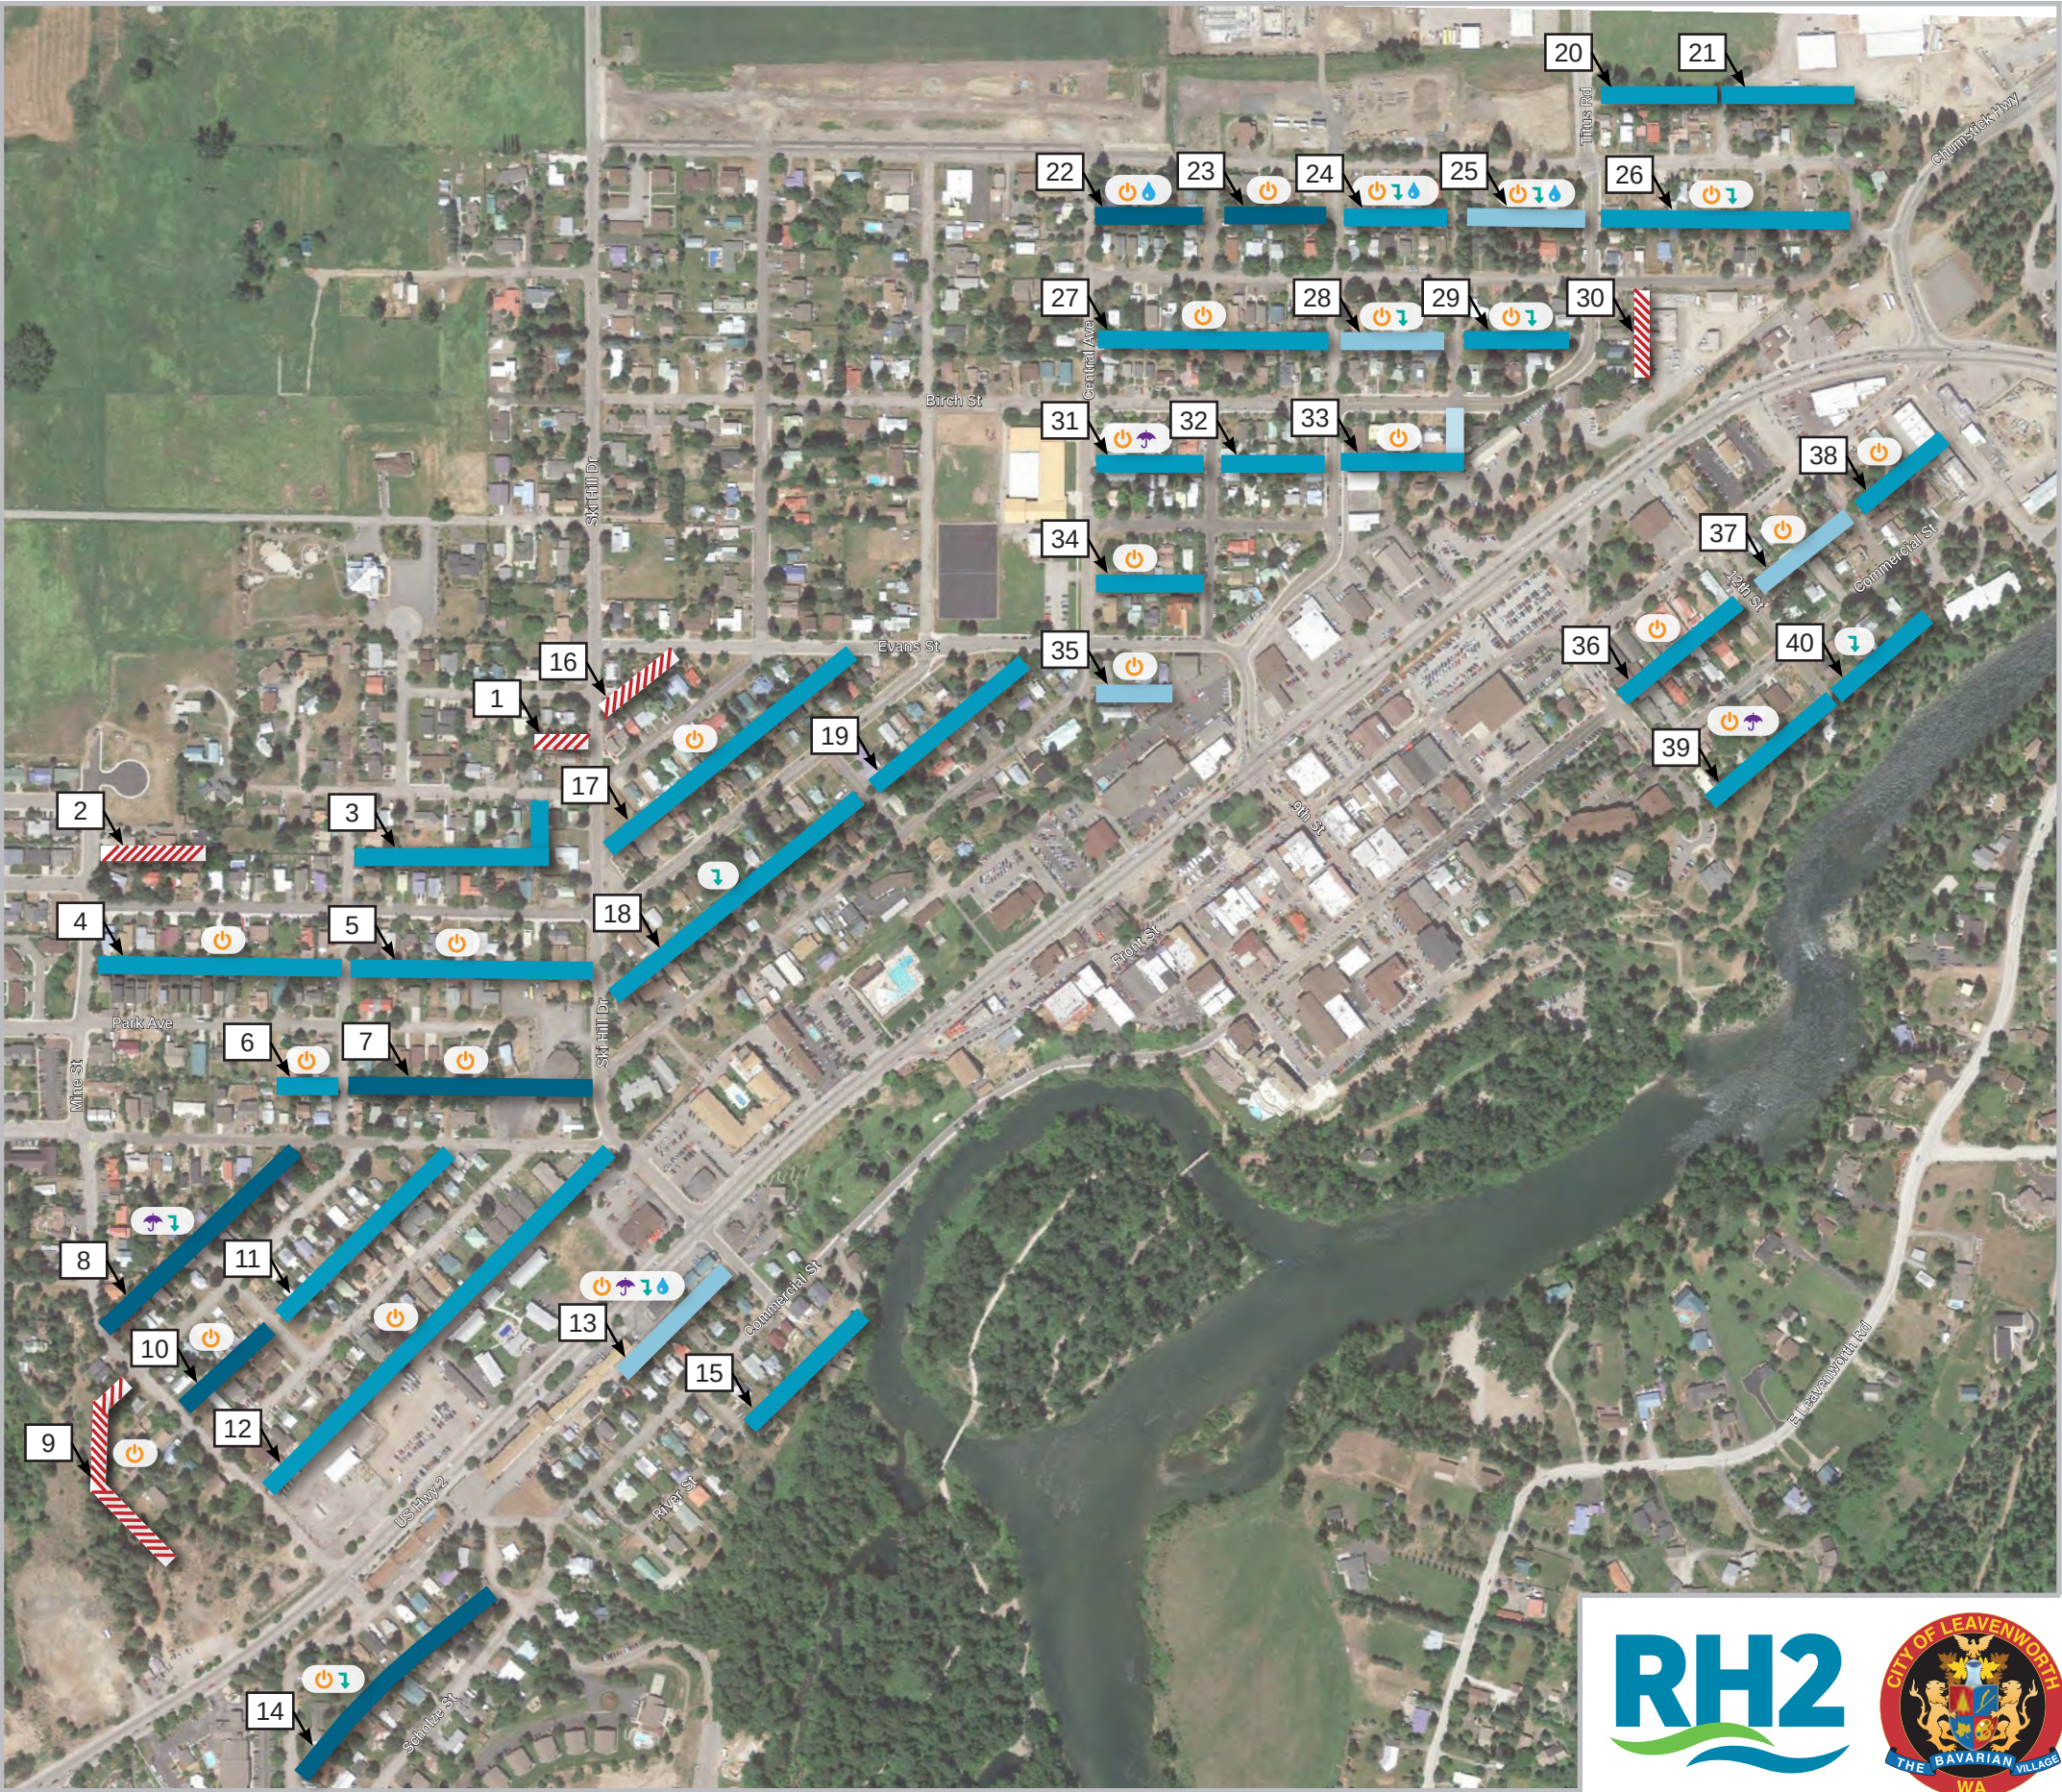
# Measurable Widths and Utilities

Note, blank alleys had no observable utilities.

//// = Inaccessible Alley

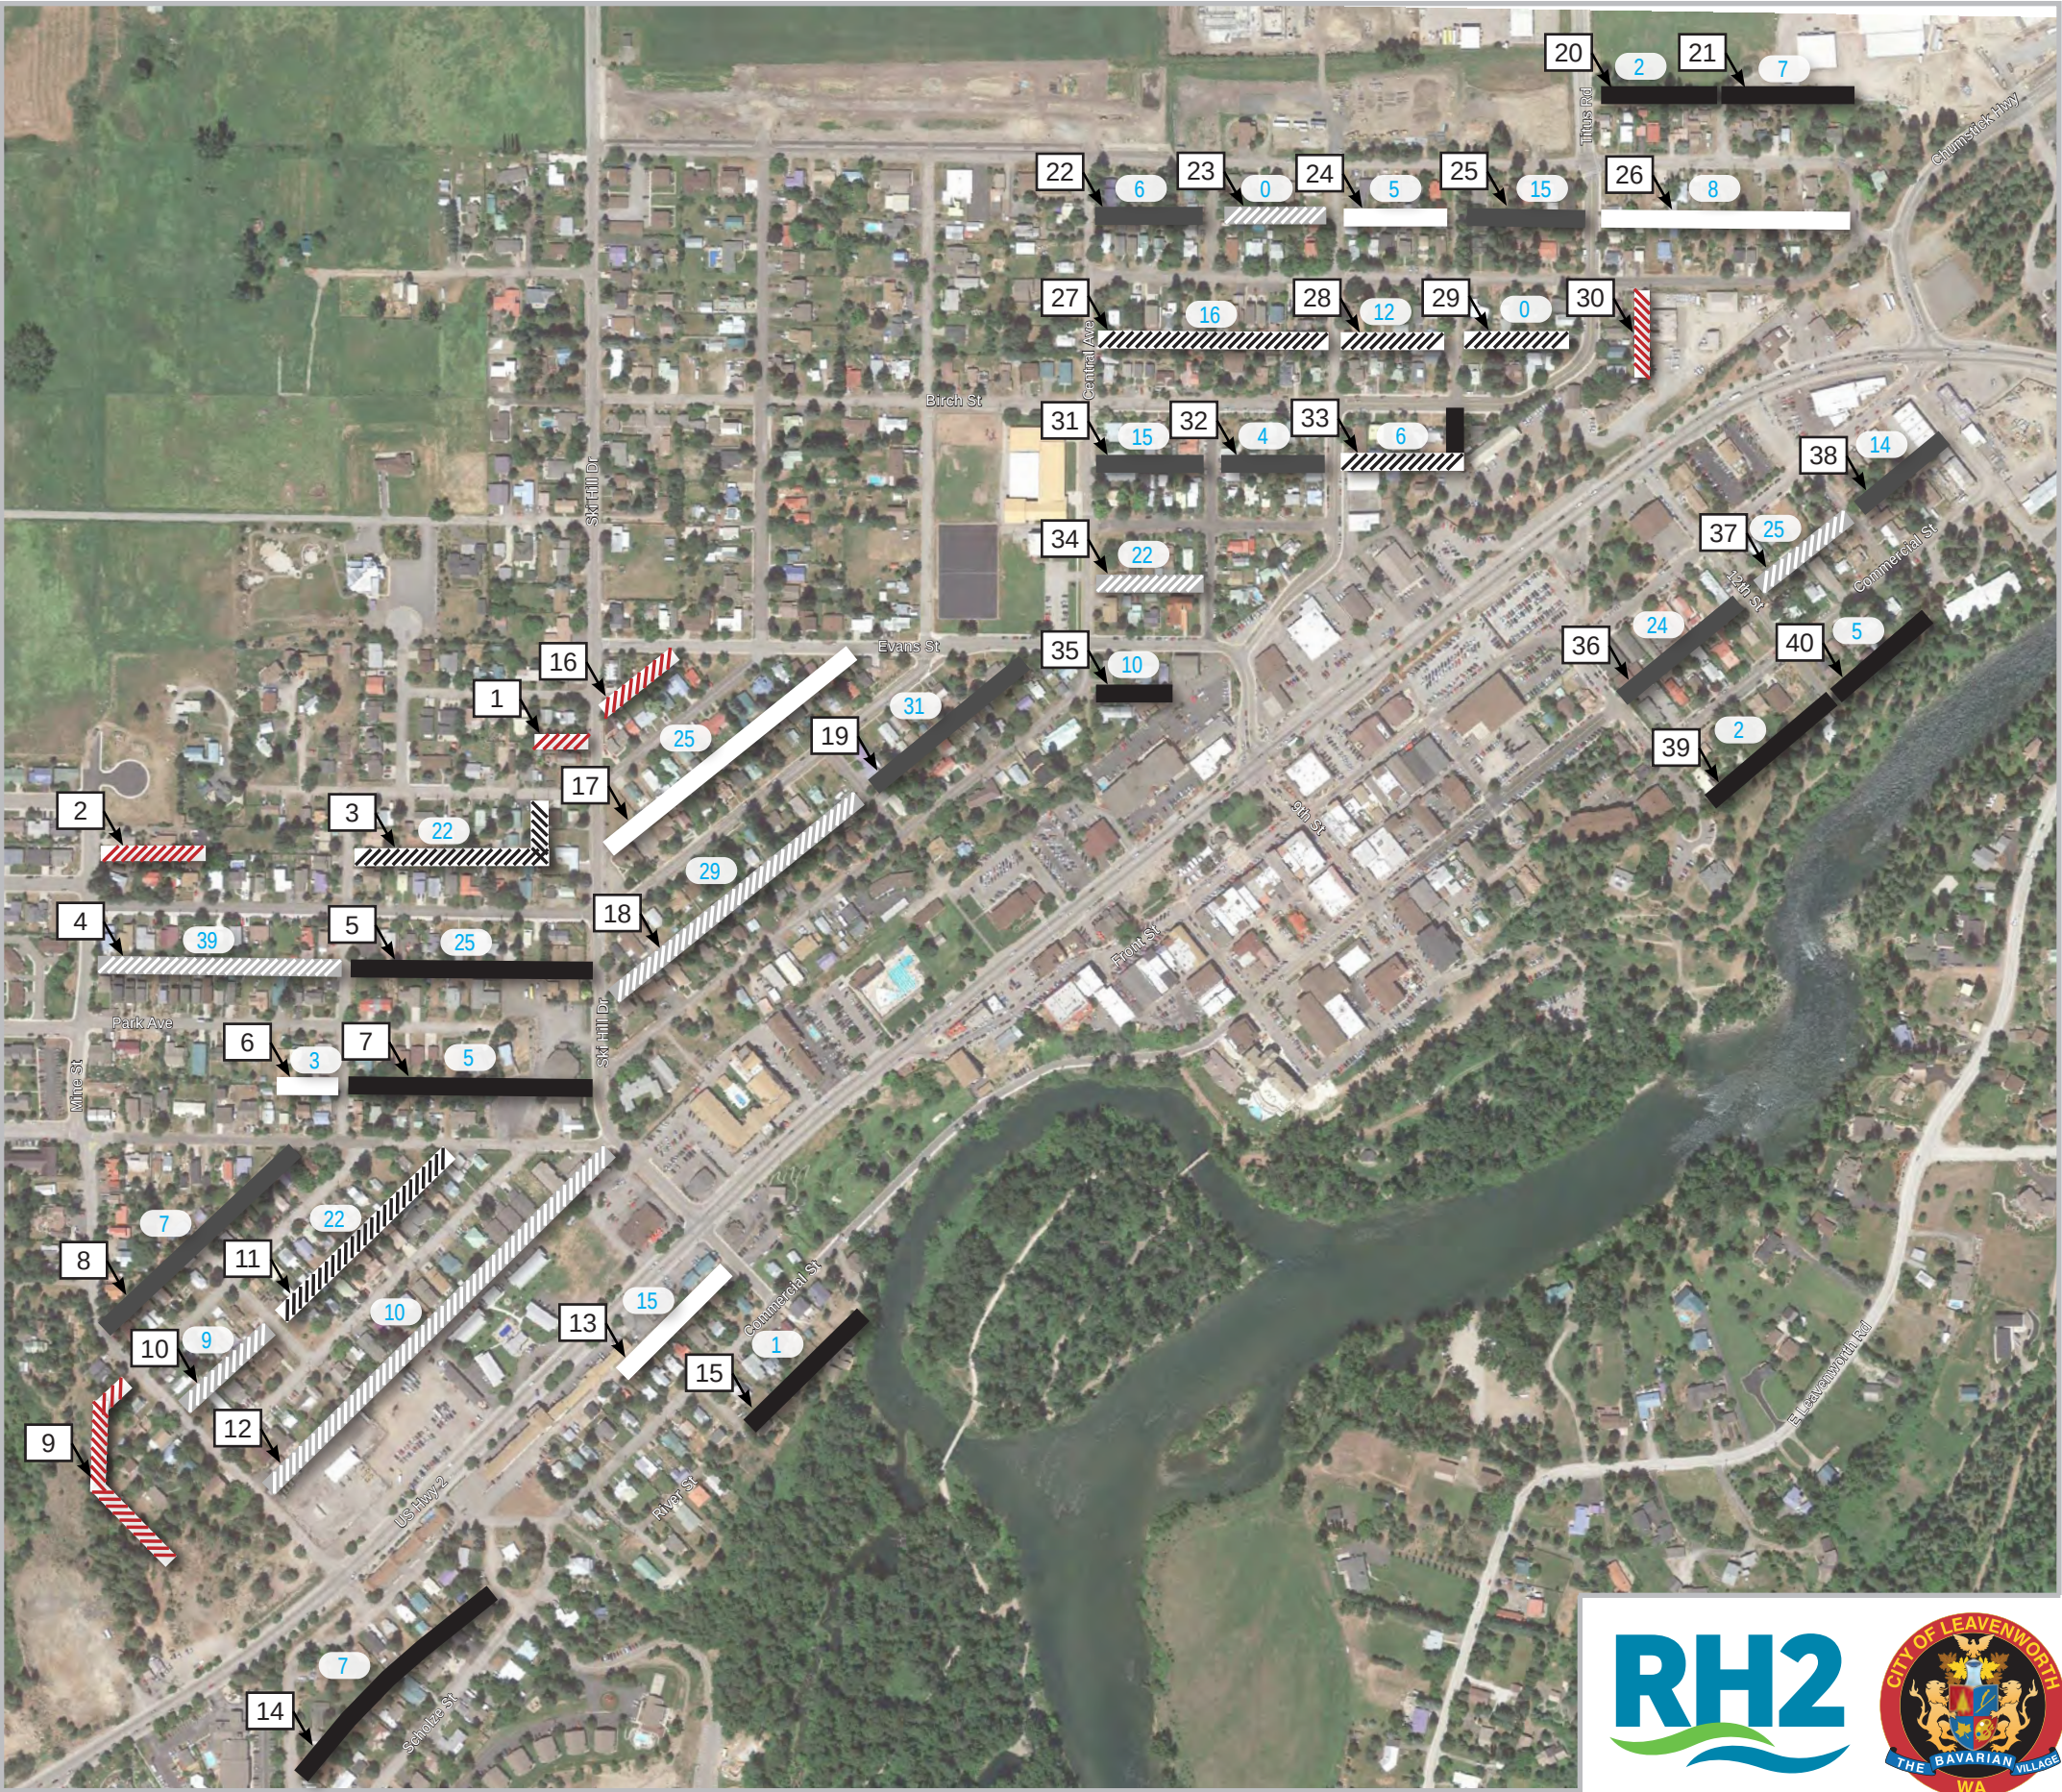
# Parking Stalls and Potential Snow Shedding Structures

= Inaccessible Alley

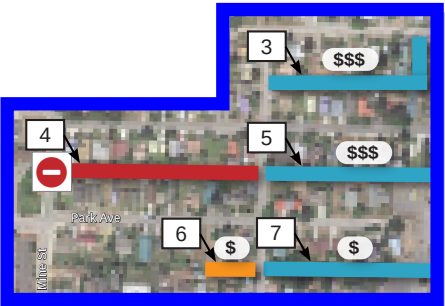
| Surface Description: West end has ~4" deep pothole, ½ usable width. Remaining is primarily fines with some aggregate, rocks/vegetation on either side of the usable alley width. | | | Drainage Pattern: East end drains to the east. Remainder of alley drains to the west. | |
| Public Works Notes: NA | | RH2 Walk-Through Notes: Buried power & cable locate on the north side of alley. Buried cable pedestal observed on south side of alley. East end of alley ends within Nazarene Church parking lot. Alley ties into the parking lot. 8 large, mature trees appear to have their trunks located within ROW. | | |

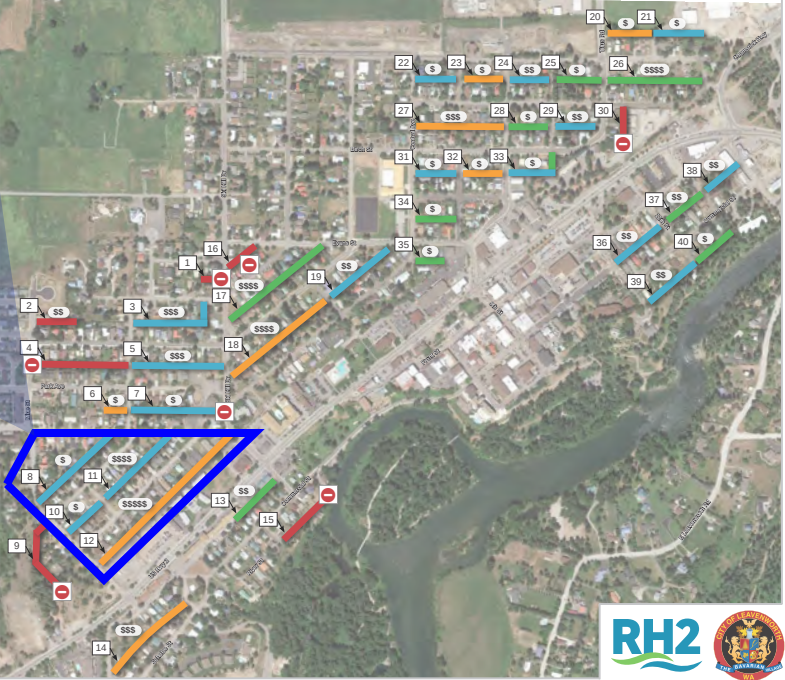
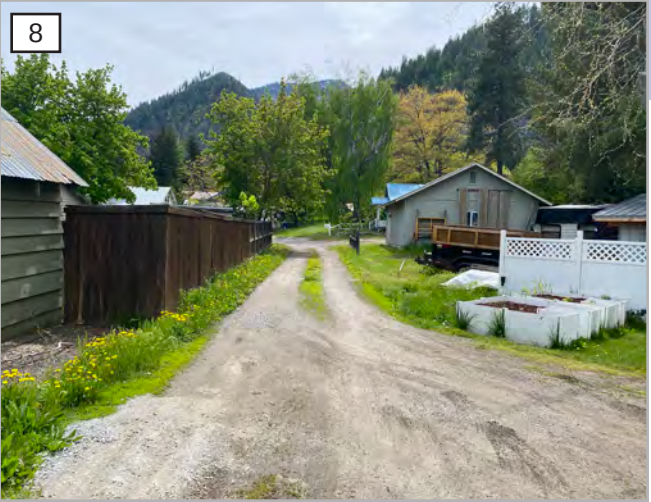
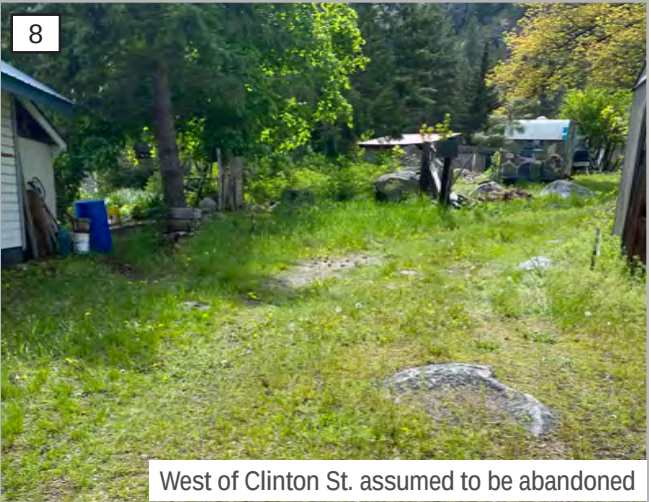
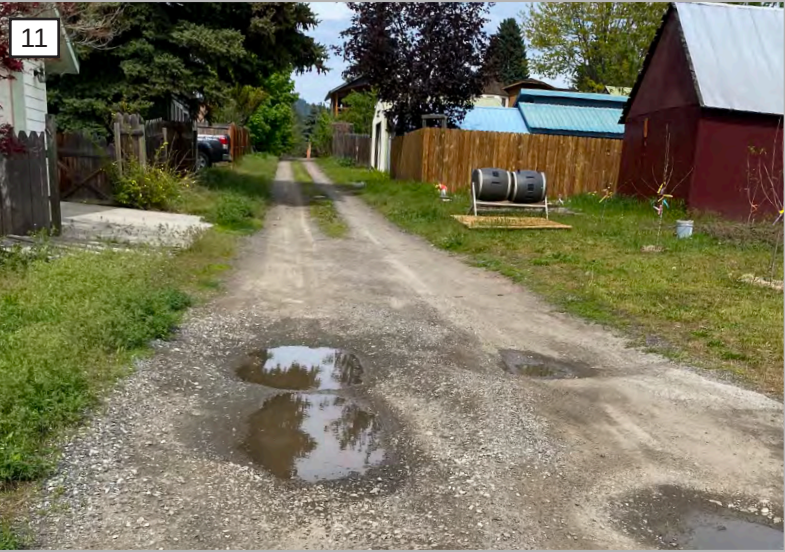
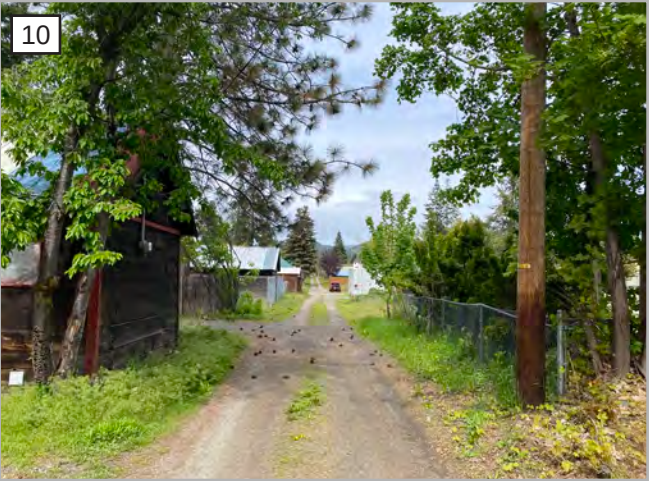
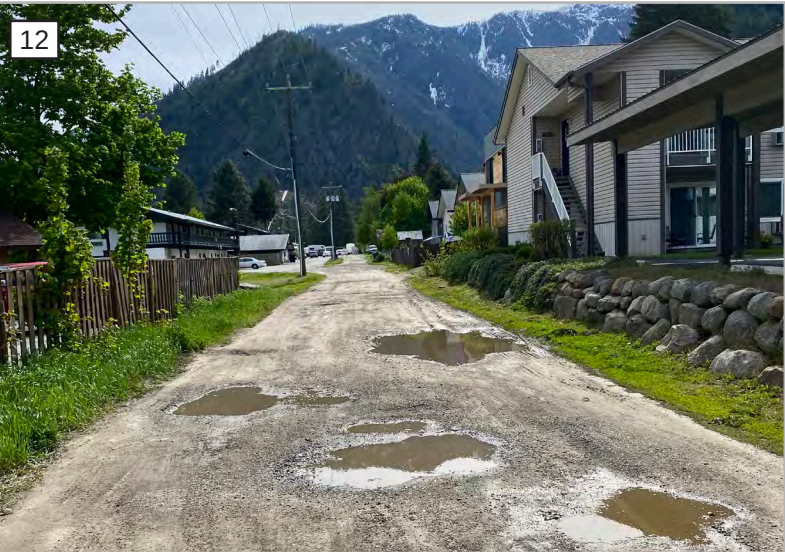
| <b>Surface Description:</b> East side is primarily fines, large potholes/washboarding. Center has Large potholes. West end has Potholes & washboarding. | | | <b>Drainage Pattern:</b> |
| <b>Public Works Notes:</b> No City utilities and west end is very tight to get through. | | | <b>RH2 Walk-Through Notes:</b> Overhead power on south side of alley. Alley provides commercial access to 2 motels, 1 coffee shop & architecture office, and a City-owned parking lot. |

| Prioritization Ranking No. | Alley Section No. | Description of Improvements | Cost Group* |
|---|---|---|---|
| 29 | 8 | Widen to minimum 10' width. Surfacing repair. Minimal vegetation removal. | \$ |

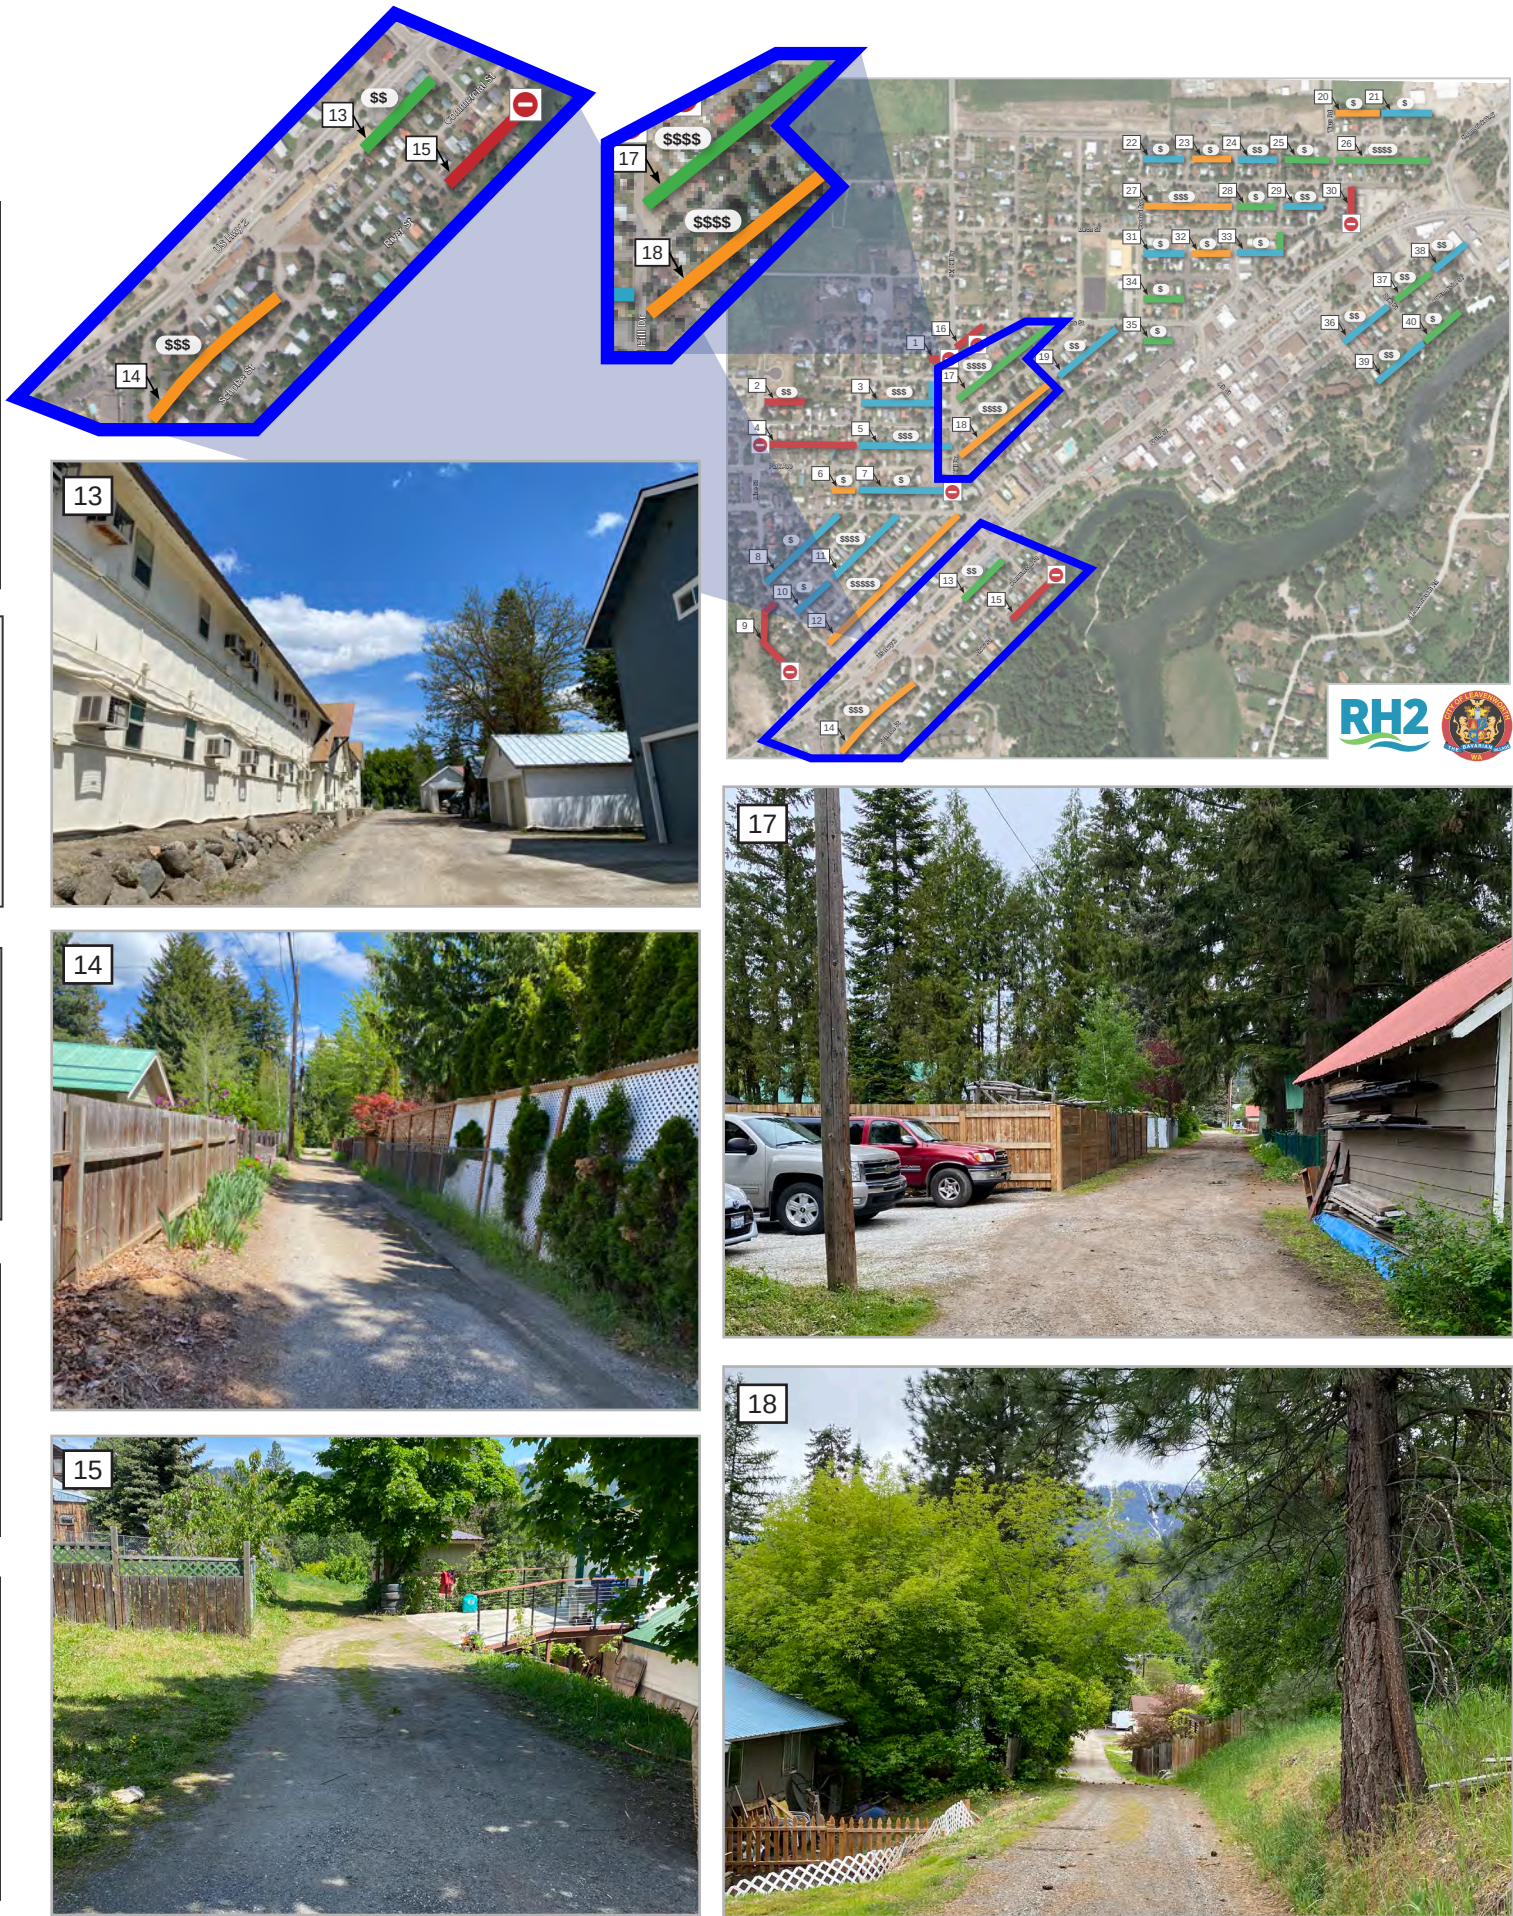
| Surface Description: East side is generally well graded aggregate. West side has some potholes. | | Drainage Pattern: East side drains to the east, center drains to the west, low spot in center of west half, west end drains to the east. | | |
| Public Works Notes: Roofs shed snow that shed into alley. Gravity sewer main crosses alley ~2 to 3 parcels from the west end. | | RH2 Walk-Through Notes: Substantial overhead tree growth. Alley is generally built within an existing slope-banks on either side of alley limit its usable width. | | |

| Prioritization Ranking No. | Alley Section No. | Description of Improvements | Cost Group* |
|---|---|---|---|
| 5 | 13 | Pothole washboarding, and surfacing repair. | \$\$ |

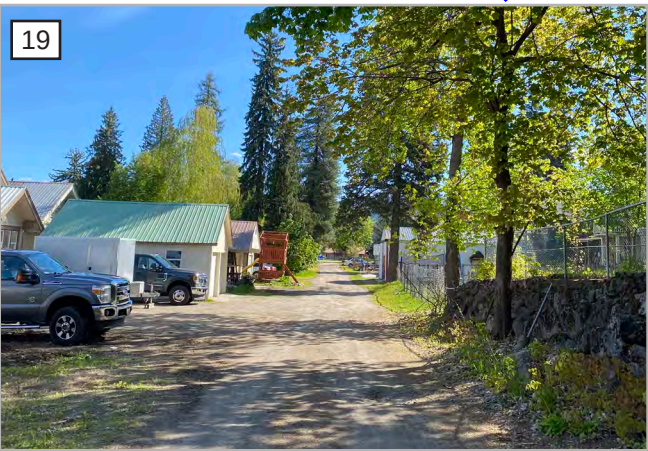
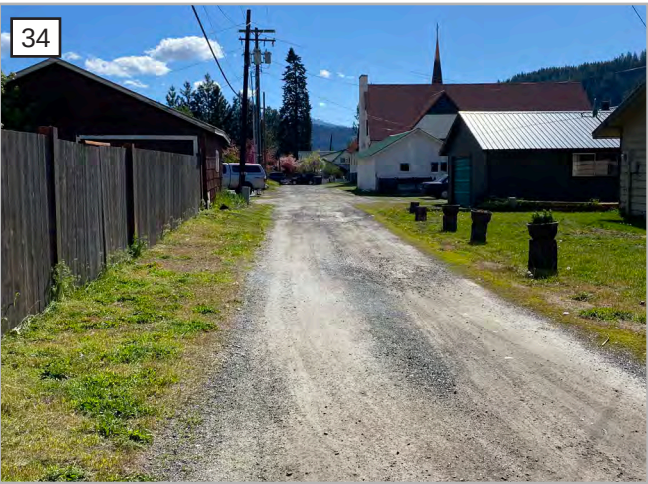
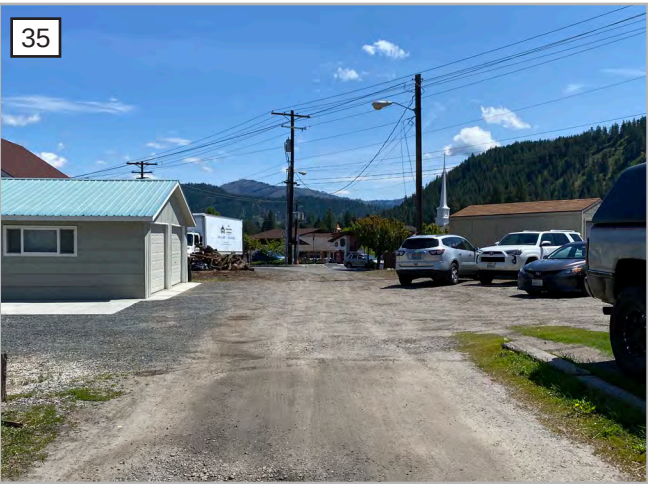
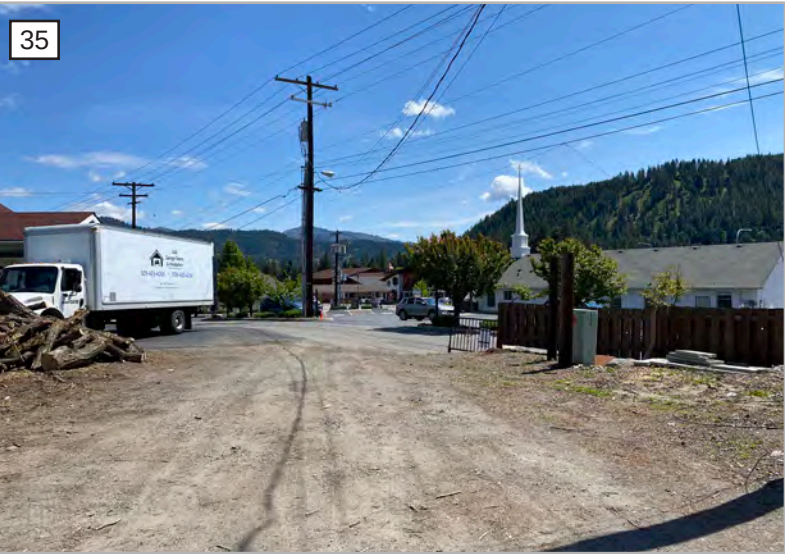
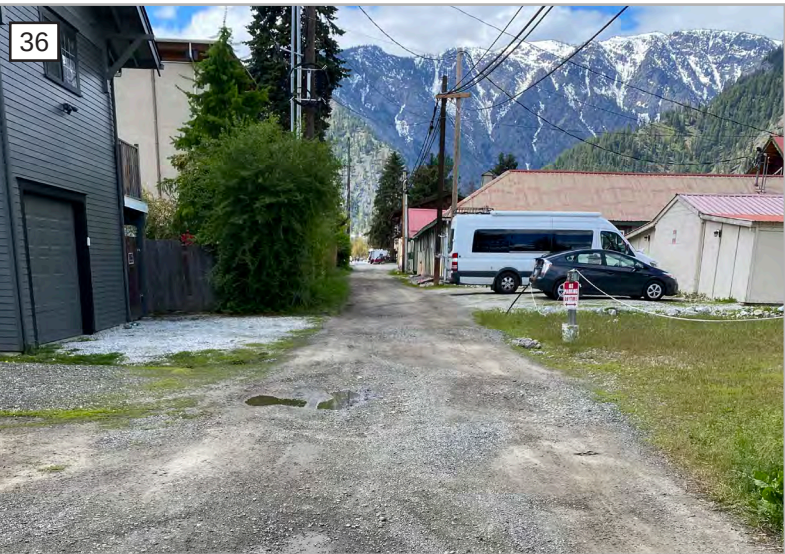
| No: 19 | PASER Rating: 3-4 | Width: 11' | Primary Usage: Parking/Access | |

| Surface Description: West end has HMA surfacing, remainder of alley is fine-grained surfacing with potholes 3" to 6" deep. | | | Drainage Pattern: Assumed drainage is infiltration with alley. | |
| Public Works Notes: Hotel is likely within ROW. | | | RH2 Walk-Through Notes: West end of alley serves commercial properties and the alley is paved. Remainder of the alley serves residential parcels. Overhead power on north and south sides of alley with a crossing near center of alley length. | |

| Prioritization Ranking No. | Alley Section No. | Description of Improvements | Cost Group* |
|---|---|---|---|
| 5 | 19 | Pothole and surfacing repair. Minimal vegetation removal. | \$\$ |

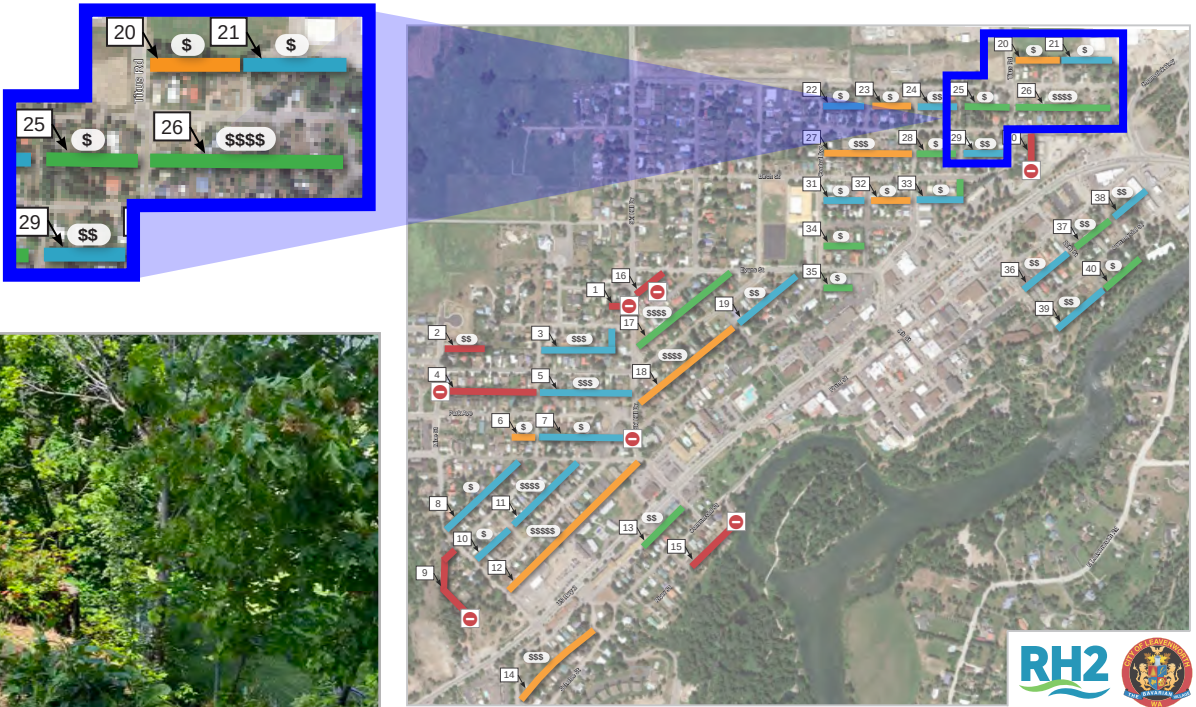
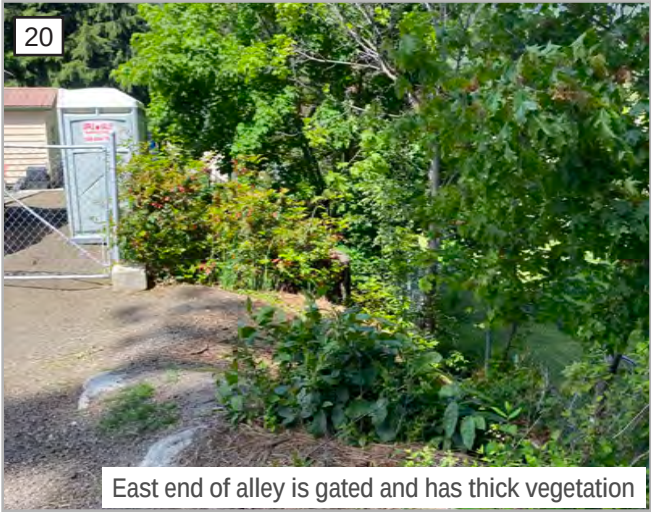
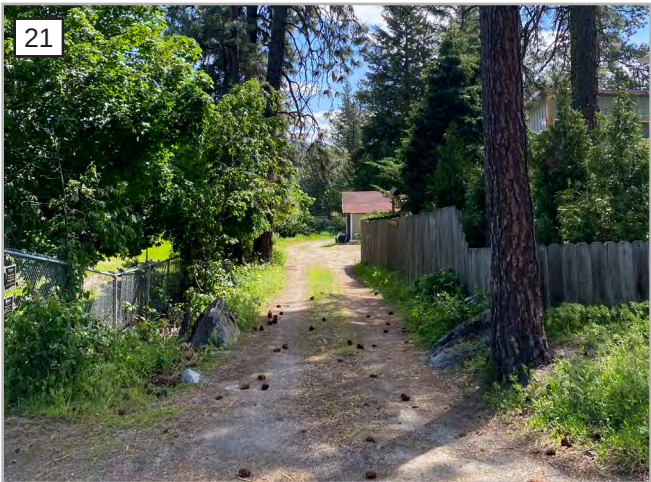
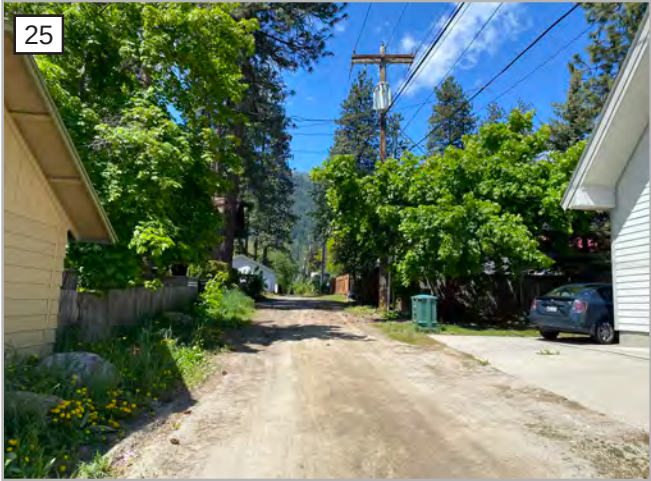
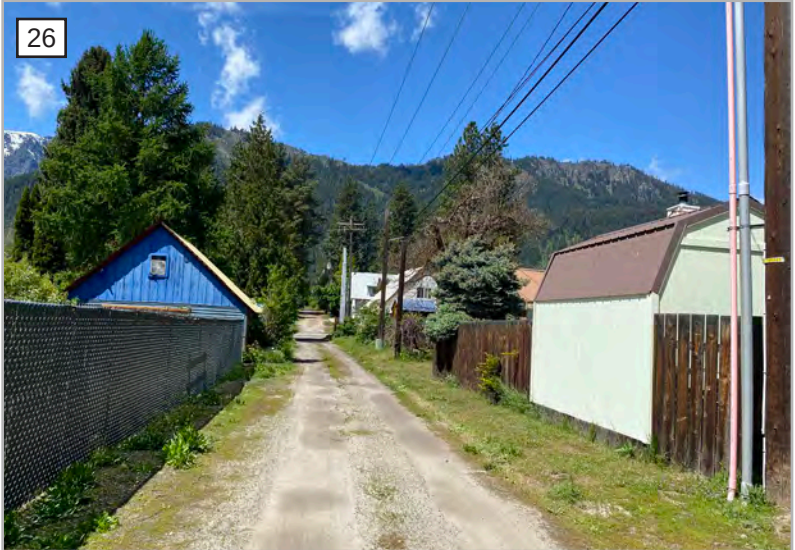
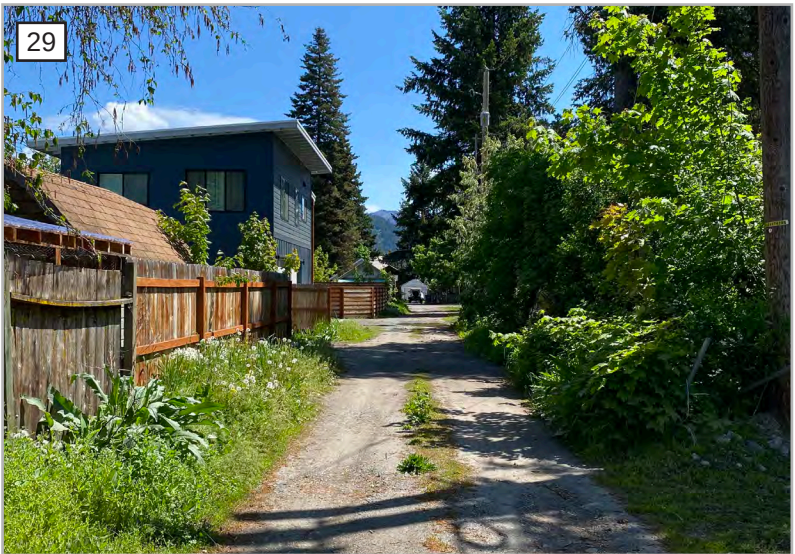
| Surface Description: Minimal aggregate, substantial potholing/washboarding | | | Drainage Pattern: Drains to the east. | |
| Public Works Notes: Nothing noteworthy. | | | RH2 Walk-Through Notes: Overhead power and buried communication on south side of alley. | |

| Prioritization Ranking No. | Alley Section No. | Description of Improvements | Cost Group* |
|---|---|---|---|
| 25 | 20 | Surfacing repair. Moderate vegetation removal. | \$ |

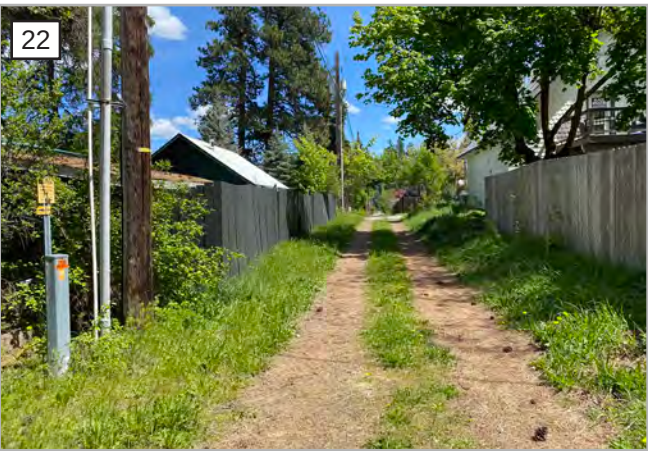
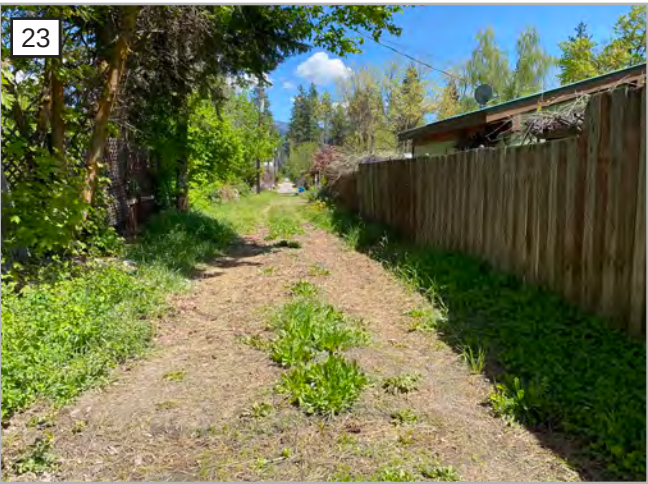
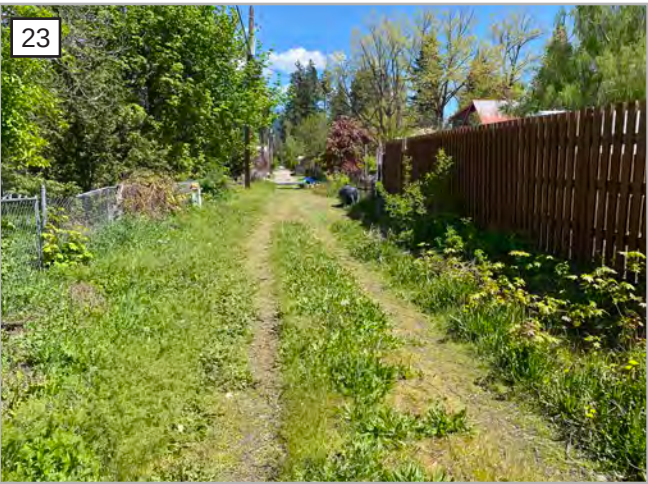
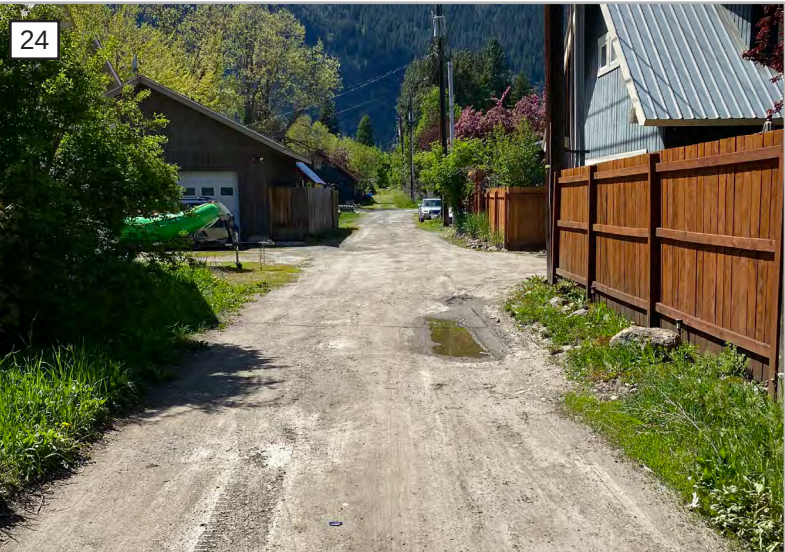
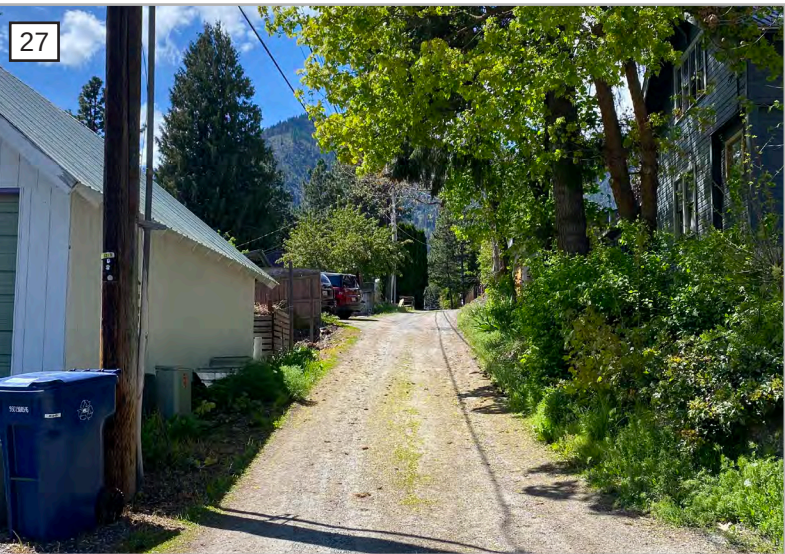
| Surface Description: East end has fines with some small aggregate. Center has 1'+ rocks in surface with pine needles and minimal aggregate. | | | Drainage Pattern: The west end of the alley drains to the west while the remainder drains to the east. | |
| Public Works Notes: City does not maintain west of Summit Ave. Does not maintain east half. | | | RH2 Walk-Through Notes: Alley accessible via City ROW form Summit Ave. Overhead power and buried cable on south side of alley | |

| Prioritization Ranking No. | Alley Section No. | Description of Improvements | Cost Group* |
|---|---|---|---|
| 32 | 22 | Widen to minimum 10' width. Surfacing repair. Overgrown vegetation removal. | \$ |

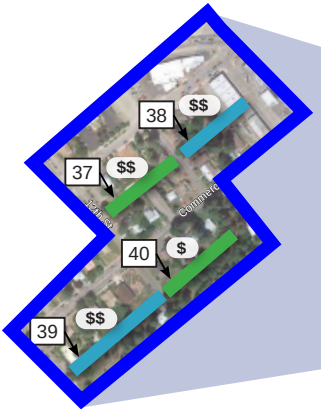
| Surface Description: Generally well graded with minor washboarding and aggregate displacement. | | | Drainage Pattern: East side of all slopes to the east with a cross slope to the south. Remainder of alley is flat with a cross slope to the north. | |
| Public Works Notes: City does not maintain. Sewer services at the east end. | | | RH2 Walk-Through Notes: N/A | |
